# BELZONA HELPS EXTEND DREDGE PUMP RUN TIME

ID: 9029

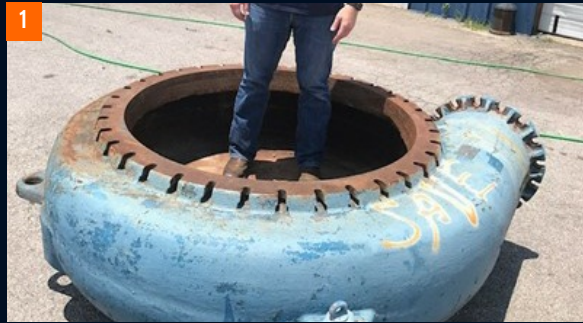
1. Large Pumps Arrive at the shop for coating
2. Belzona 1814 applied inside
3. Belzona 1814 applied to all wear areas of the pump

Pump was brought to the shop  
SP10 minimum 3-mil blast  
"Priming" coat of 1331 was applied to help with increasing shear adhesion of the 1814  
1/4" of 1814 applied to the entire pump internals.
