# FLANGES FORMING

ID: 9035

New flanges 48" needed for a renovation on a oil rig

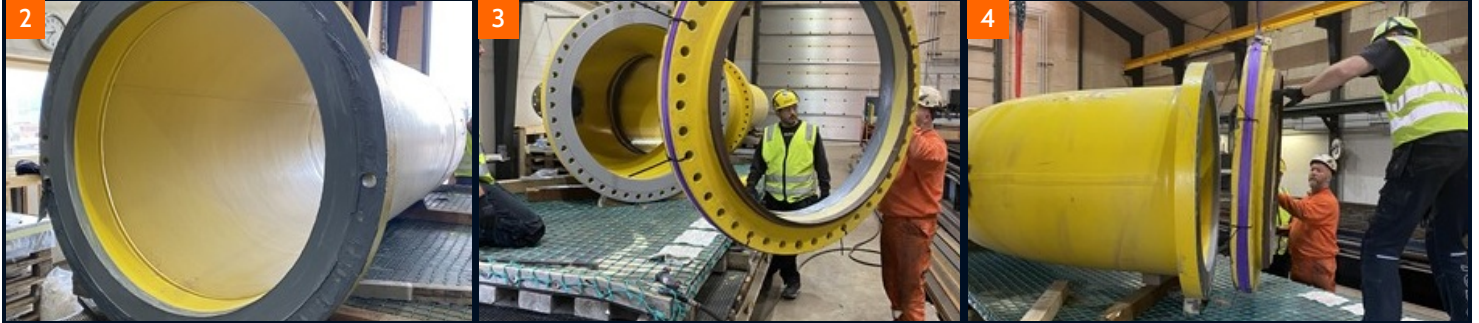
## PHOTOS

1. 48" pipe
2. Belzona 1111 was used
3. 600 kg counterpart is mounted
4. 600 kg counterpart is mounted

The customer was looking for a quick solution to form new flanges on an urgent project.  
Saving the time and money.

Flanges forming techniques

They used Belzona because of the fast cure and its ability to meet the requirements for flange
