# BELZONA PROVIDES ECONOMICAL COATING FOR LARGE COOLING WATER IMPELLER

ID: 9042

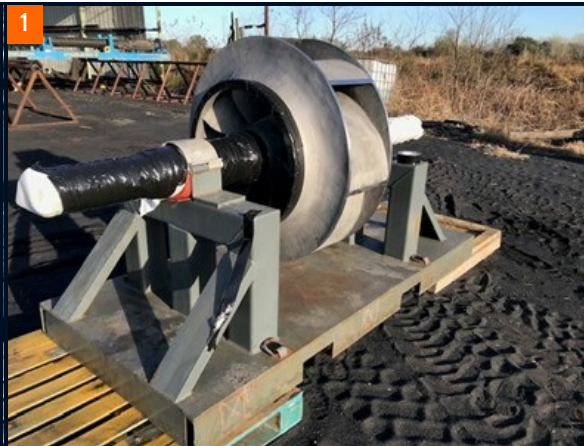
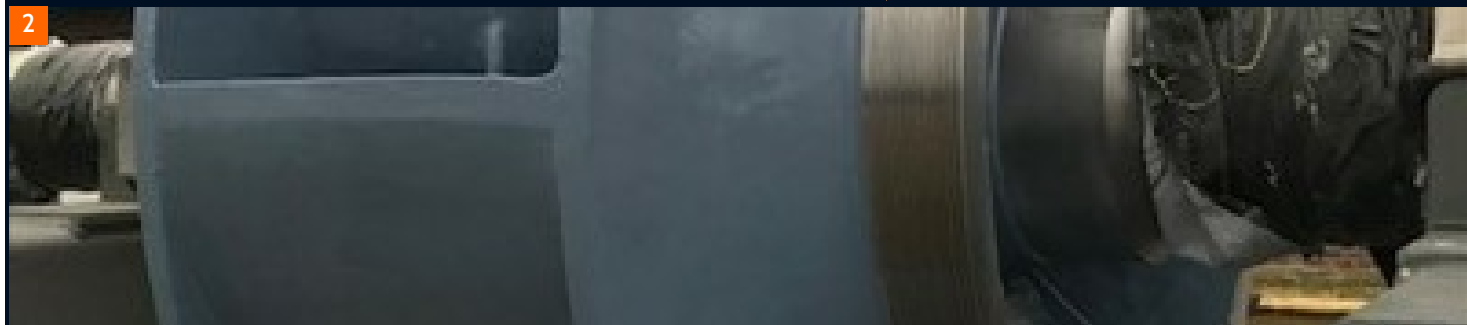
1. Impeller prior to the application
2. Completed application

Blasted to SP10 minimum 3 mil profile per the IFU

Two coats of Belzona 5821 were applied to the impeller wet areas.
