# BELZONA BONDS PIPE SUPPORTS ON TOP OF A CHEMICAL TANK ROOF.

ID: 9067

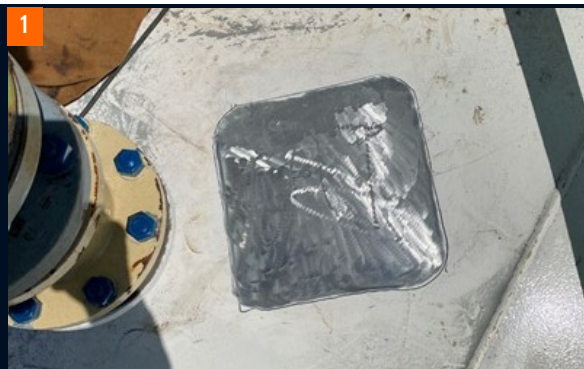
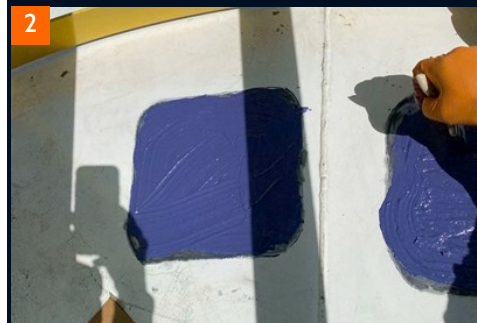
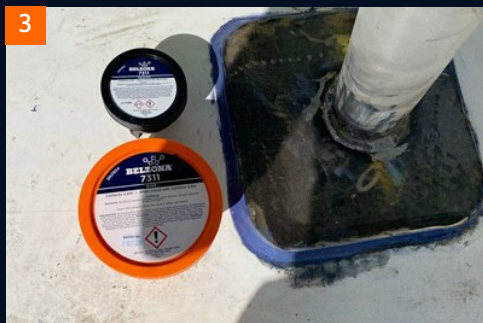
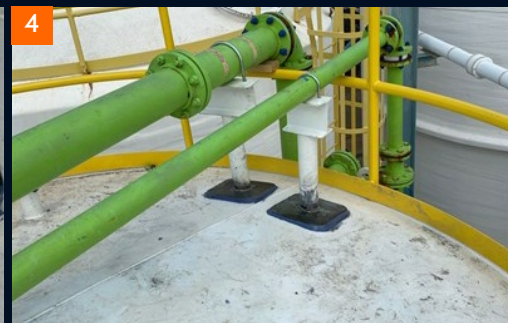
Installation of five 12"x12" pipe supports on top of a newly rubber-lined Sulphuric Acid (H<sub>2</sub>SO<sub>4</sub>) tank.

Pipe supports on top of a Chemical Storage Tank within a Petrochemical facility.

The five support areas were ground to SSPC-SP11 cleanliness and a 75 microns profile, prior to the Belzona 7311 being applied at the recommended 2mm thickness onto the tank roof and pipe support. The application was carried out in accordance with Belzona System Leaflet TCC-06.

Welding was not an option as it would have burned the internal tank lining. The Customer was very impressed with the ease of application and performance of Belzona 7311, successfully winning the Distributor a couple more pipe support bonding applications.
