# ENCAPSULATING A STEEL PLATE BETWEEN NEW AND OLD CONCRETE IN A DISCHARGE SUMP

ID: 9071

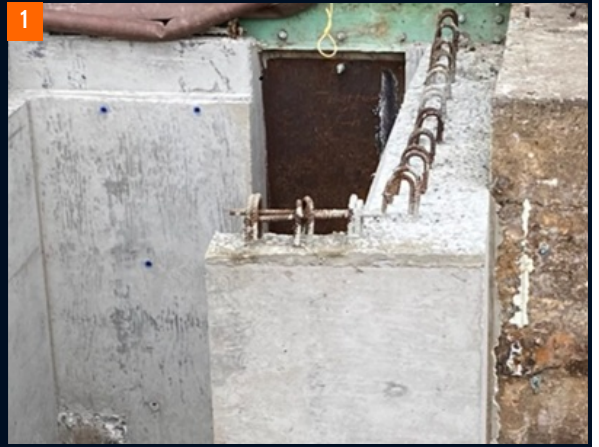
1. Steel plate, uncut, before the concrete floor and surrounding building were installed.
2. Sealed seam, concrete-steel-concrete.

Surface was prepared using grinders and hand tools inside the sump. Then cleaned out and dried as long as possible before application of the conditioner.
