# BELZONA REPAIRS DAMAGED FLOOR IN STERILE CARTWASHING AREA IN LOCAL HOSPITAL

ID: 9087

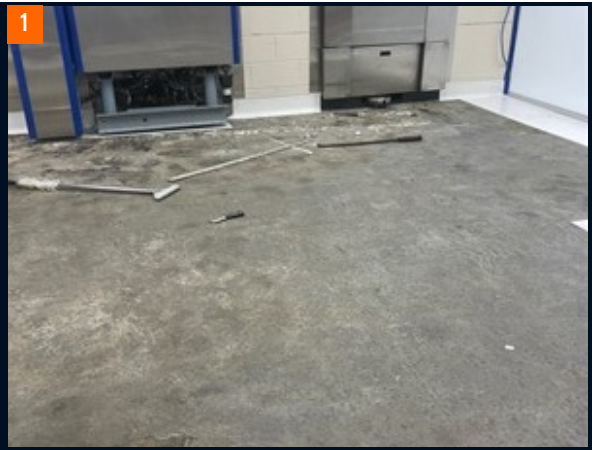
1. Vinyl Flooring Removed
2. Floor area grinded
3. Belzona 1321 applied in front of Cartwash units
4. Belzona 4311 applied to rest of the area

Arrived at hospital Saturday morning at 8 aM. We taped off and cut out existing vinyl flooring. We then grinded entire floor with Hepa filter concrete grinder. After cleaning the floor we repaired uneven areas with Belzona 1121. We taped off Cart entrances and applied two coats of Belzona 1321. Came back Sunday morning and taped off rest of area , applied one coat Belzona 4911, and applied two coats of Belzona 4311. Application finished at 12 noon and Hospital crew came in later in evening to reassemble the room. Area put back to use Monday morning.
