# REPAIR AND PROTECTION OF FIXED CONE FREE VALVE FOR HYDROPOWER PLANT

ID: 9113

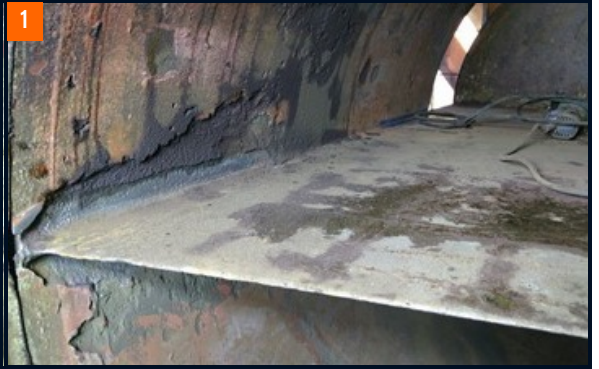
A Howell Bunger Free Discharge valve is commonly used for handling high flow rates from dams and reservoirs. The valve was inspected identifying severe corrosion, erosion, and wall thickness loss of the internal flow dividing walls; specifically at the fixed cone, valve's body, and shutter.

1. Damages to the valve's body.
2. Belzona 1111 used to repair and rebuild the valve's body.
3. First coat of Belzona 1341N applied to the valve's body.
4. First coat of Belzona 1341N applied to the fixed cone.
