# BELZONA PROVIDES ANTI-CAVITATION RESISTANCE TO DRIVE SHAFT

ID: 9116

Anti-cavitation system being applied to a drive-shaft of a submarine.

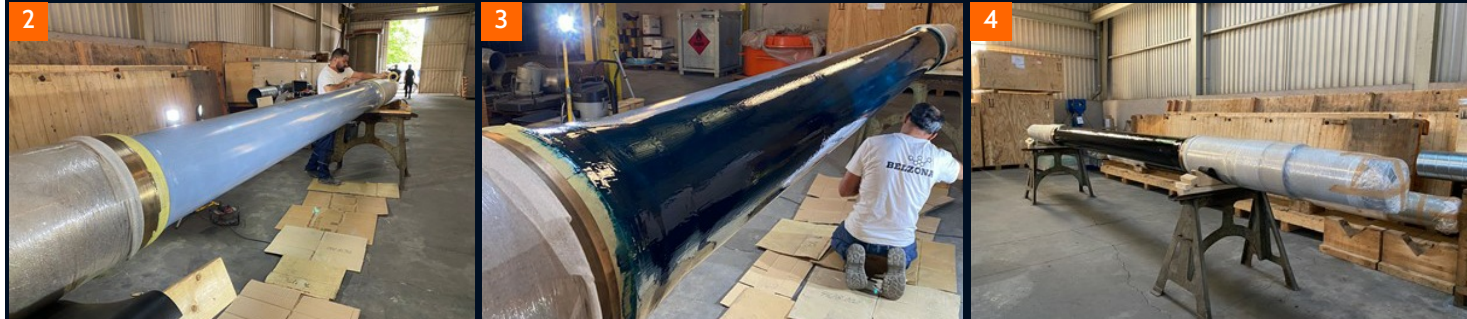
## PHOTOS

- 1.) Driveshaft after grit blasting
- 2.) 2 coats of Belzona 1341 applied
- 3.) 1st coat of Belzona 2141 being applied
- 4.) Final application - 2 coats of Belzona 2141

This application was carried out in accordance with adapted versions of system leaflets SOS-6 & SOS-2. First, the drive shaft was grit blasted to SA2.5, achieving a 75-micron profile. After surface preparation, any required areas were rebuilt with Belzona 1311 before 2 coats of Belzona 1341 were applied. Finally, Belzona 2941 conditioner was applied before 2 coats of Belzona 2141.
