# COLD REPAIRS TO REMEDY THE DAMAGES CAUSED BY WELDING

ID: 9165

## PROBLEM

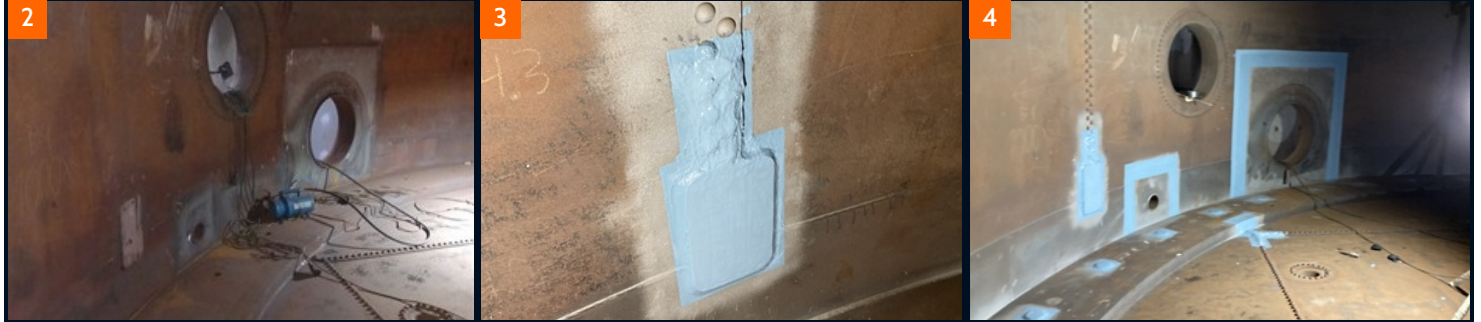
1. Small metal plate welded on the tank
2. General View of the tank
3. Localised repair
4. Section of the tank completed

Belzona 1511 was required to create a taper between the welded plates and the existing tank structure, before being overcoated using Belzona 1391T. The small circular plates were used by the contractor to plug holes where they pour a low cost mortar to fill the void.

Around the riveted sections, Belzona 1511 was used in conjunction with the reinforcing mesh Belzona 9341, before overcoating using Belzona 1391T.

Grit blasting of the section in order to achieve the required profile and cleanliness, before applying the paste grade Belzona 1511. Whilst in the overcoating window, Belzona 1391T was applied in 2 coats of 450 microns.
