# BELZONA PROTECTS PIPELINES ON OFFSHORE PLATFORM

ID: 9166

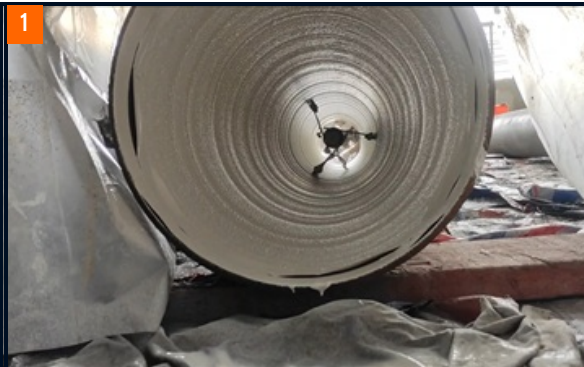
1. Belzona 1331 is being sprayed inside the pipeline
2. Spraying application completed
3. Inspect the surface profile after surface preparation of welded flange.
4. Pipe installation

Application was carried out with an adapted version of Belzona System Leaflet VPF-02. The inner linings of pipes and elbows are applied with Belzona products using spraying guns and brushes.
