# BELZONA PROVIDES ANTI-CORROSION PROTECTION FOR SEWAGE DISCHARGE OUTLETS OF EGC SYSTEM

ID: 9168

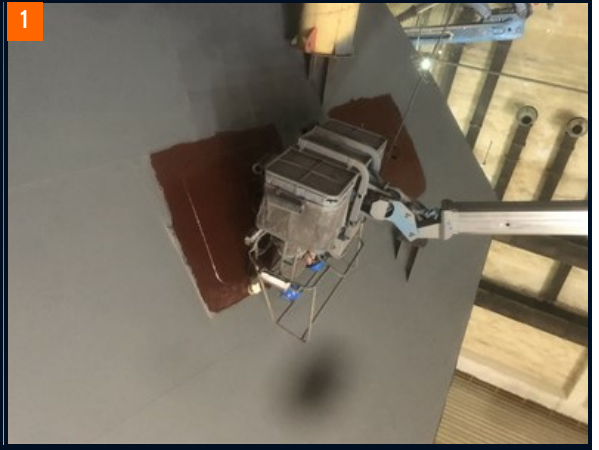
1. Surface preparation
2. Surface profile and cleanliness inspection of the target area after surface preparation
3. The first coat of Belzona 4311 (grey) was being applied
4. The second coat of Belzona 4311 (red) was completed

The application process strictly adhered to Belzona's standard procedures. Each ship's designated coating area underwent grit blasting and cleaning, with subsequent testing of the surface profile and cleanliness of the target area after surface preparation. Upon successfully passing the tests, the Belzona 4311 double coating application commenced. Throughout the operation, it was imperative to closely monitor temperature and humidity conditions, as well as the wet film thickness of the coating.
