# BELZONA COATS AGING CARBON STEEL PIPELINE

ID: 9196

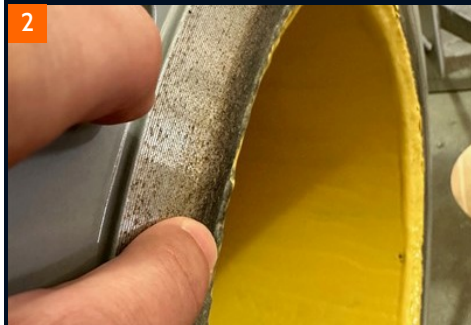
1. The carbon steel pipes that needed to be coated
2. Damage to aging pipe
3. Internal coating of Belzona 5821 on pipe
4. Two coats of Belzona 5821 applied onto external pipes
