# HANDRAIL BONDING ON OFFSHORE DECK

ID: 9253

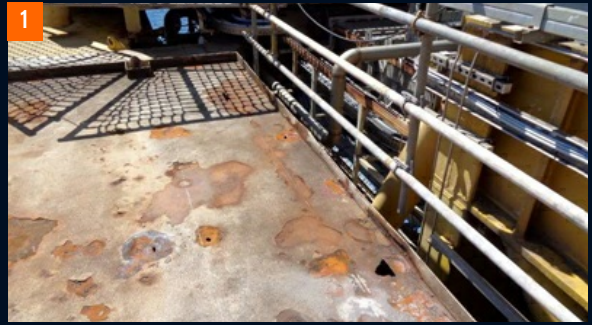
A new handrail was designed on an offshore loading deck just above critical lower deck. Because there were some holes in the deck due to corrosion, welding new plates was not clients first choice. A very strong bonding was required and had to be designed and calculated. Also the flexibility of the Belzona 7311 was preferable because large containers could impact into the handrail.

1. Deck before application
2. Fixing the holes with Belzona 1161 and re-inforcement sheets
3. Bonding the small plates with Belzona 7311. The bigger plate was bonded with Belzona 7311 and injected with Belzona 5811.
4. Application ready to be top coated.
