# NEW DOUBLE WATER BOX TRAINE CHILLER

ID: 9269

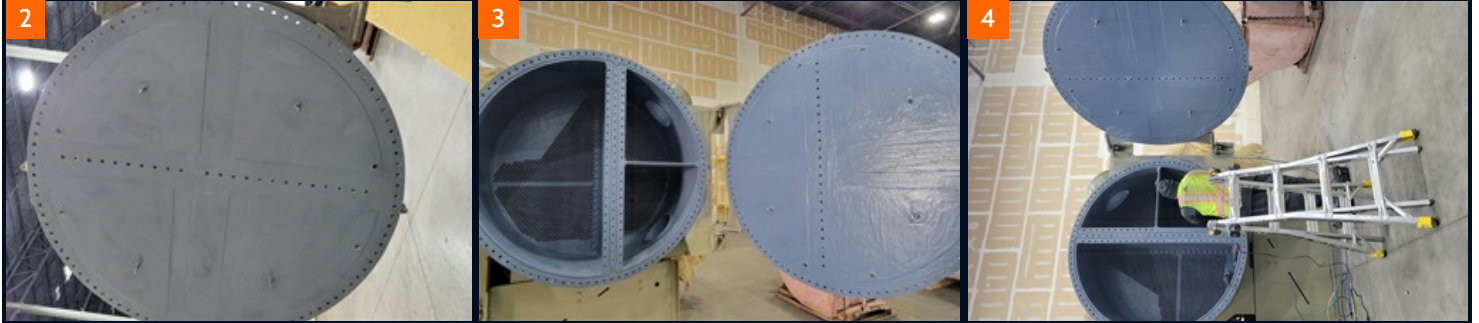
1. Overview of chiller
2. Application of Belzona 1121
3. Application of Belzona 1321
4. Application of Belzona 1321

The application was carried out in accordance with Belzona Know-How System Leaflets HEX-1, HEX-2, and HEX-3. Belzona 1121 was use to seal all the seams before coating, Belzona 1321 was applied in two coats after Belzona 1121 was cured. The product was applied by hand. Corks were inserted before blasting then again before coating to protect the copper tubes. The water boxes were also coated.
