# BELZONA SUPERWRAP SYSTEM HELPS MAINTAIN COOLING SYSTEM OF NAVAL VESSEL ENGINES

ID: 9272

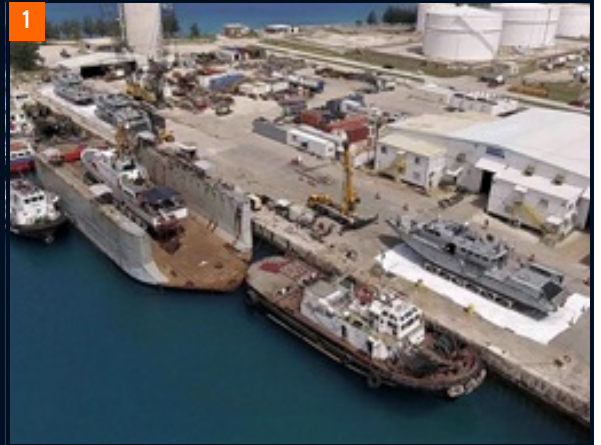
Bronze pipe system with cooling water was set going into the Naval Ship engine room. Pipes had sharp changes and angles causing internal erosion. The customer was worried that the erosion could cause thin wall and compromise the pipes. They needed a compliant pipe repair system that would insure them at least 2 years of life before the pipe would be replaced.

1. Cabras Marine Site Guam
2. Bronze Alloy Pipes to be wrapped
3. Mixing and and wetting of the Superwrap 2 inside the ship
4. Pipe wrapped and finished as per design with Belzona Superwrap 2 system

Some Rebuild had to be done around uneven geometry to leave a smooth area for the SW2 system to go on. Belzona 1161 was used for the rebuild. Surface preparation was done as per SSPC-11 Bare Metal Power tool Cleaning. Surface was cleaned with solvent cleaner and the Superwrap 2 system was applied using the 1982 resin system. A crew of four was used, 2 for mixing and 2 for wrapping. 12 Pipe sections were done in 4 days of work.
