# BELZONA 9811 ALUMINA TILES EXTEND SEPARATOR LIFESPAN FOURFOLD

ID: 9276

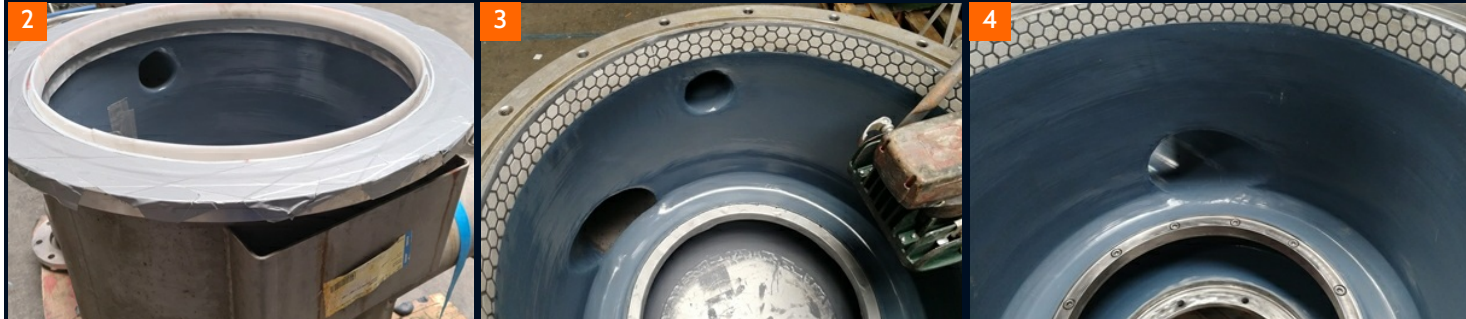
The paper industry relies on separators to filter their paper pulp, a process prone to heavy abrasion from solid particles conveyed (glass, metal, silica etc.). This equipment, as well as centrifugal pumps and pulpers, experience abrasive wear.

1. A wider view of the separator
2. Mid-application
3. The completed application
4. The completed application

In response, we incorporated the use of Belzona 9811 Alumina Tiles, significantly extending the protection lifespan by four times compared to Belzona 1812 and Belzona 1321. Despite the enhanced durability, the service cost remains similar to the previous solutions. To implement this improvement, we used Belzona 1311 (8KG), Belzona 1321 (1.5KG), Belzona 9811 (1m<sup>2</sup>) & Belzona 1812 (8KG). The customer had contemplated replacing the separator technology due to the inadequacy of Belzona 1812 and Belzona 1321 in terms of durability and cost-effectiveness.
