# PROTECTION OF SEA WATER PIPE PIECES WITH BELZONA 5821

ID: 9300

## PROBLEM

The customer was looking for a protection system for the internals of their new-build seawater pipe pieces on their luxury yachts.

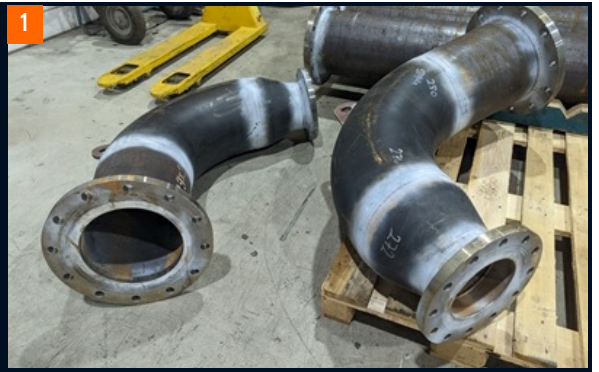
1. First set of Pipe Bends ready to be coated
2. Internals coated with Belzona 5821
3. First coat of Belzona 5821 in yellow applied to pipe straights
4. Second coat of Belzona 5821 in slate grey applied

On completion of adequate surface preparation, Belzona 5821 a ceramic-filled epoxy system was applied. The system was applied by hand in two coats. This solution is cost-effective for large surface areas given the relatively thin target thickness.
