# BELZONA PROTECTS NEW PUMPS WITH ANTI-CORROSION COATING WITH DRINKING WATER SAFETY CERTIFICATE

ID: 9311

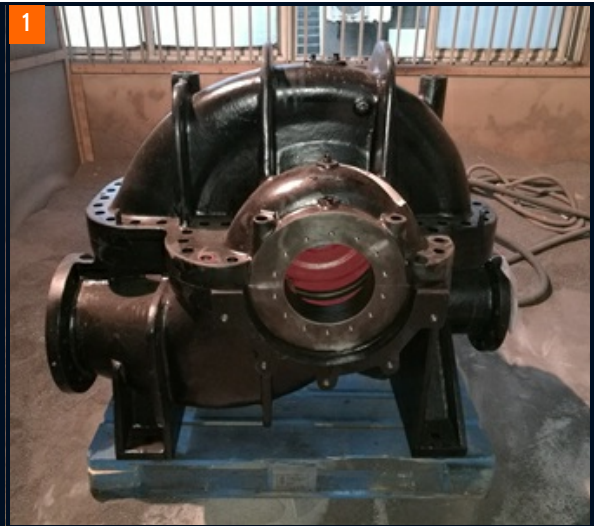
1. Before application
2. After surface preparation
3. During application of Belzona 5811 DW2
4. Application completed
