# BELZONA PROVIDES NEW PUMPS WITH ANTI-CORROSION PROTECTION

ID: 9313

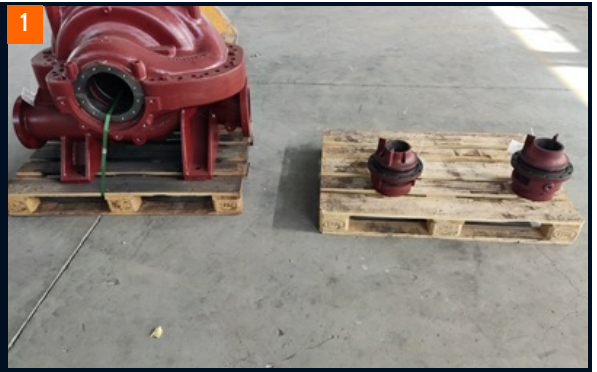
1. Before application
2. After surface preparation
3. During the application of Belzona 5821
4. DFT after cured

The medium is seawater. The seawater environment would cause corrosion of the cast iron substrate. In order to effectively protect the substrate from corrosion, Belzona 5821 anti-corrosion coating was used to prevent corrosion of the flow-passing parts of the pump casing.
