# BELZONA PROVIDES NONSKID SAFETY STRIPPING AT LUBE OIL FACILITY

ID: 9316

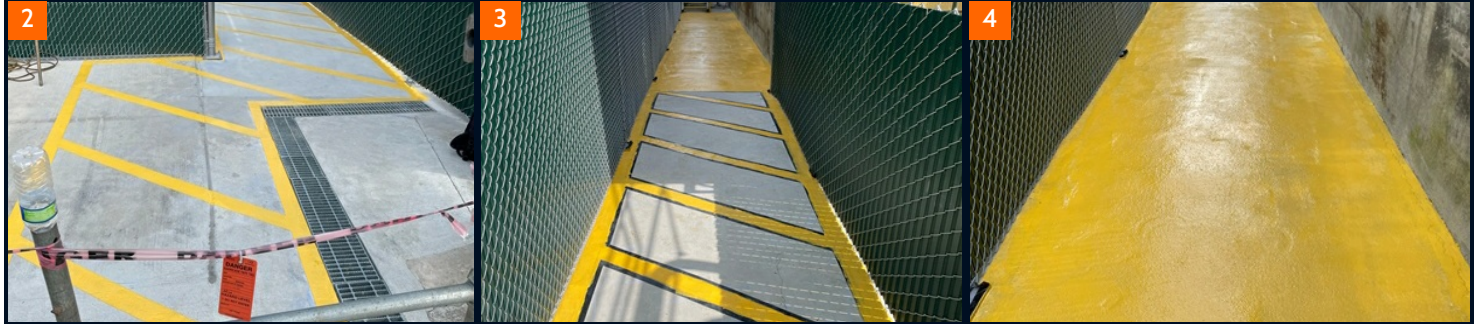
This high traffic area in this lube oil facility was in need of a nonskid safety grip system due to the potential slip and fall hazard the area presented.

1. Pre Job inspection
2. Application in progress
3. Belzona 5231 applied to half of the high traffic area
4. Application finalized

The concrete area was prepared using blast track machine with vac system in order to properly prepare concrete substrate for acceptance of coating and minimize dust in area. The area was then taped off to owner specified pattern prior to coating. The first coat of Belzona 5231 was applied as per manufactures recommendation and additional aggregate was applied in first coat to achieve additional nonskid properties. An additional topcoat of Belzona 5231 was then applied to encapsulate nonskid aggregate and provide long term nonskid solution.
