# PIPE STRENGTHENING WITH BELZONA SUPERWRAP II

ID: 9330

## PROBLEM

A 60" carbon steel pipe that had suffered from external corrosion and metal loss over the years. The defective area was about 15 feet. They required a solution that would reinstate the structural integrity of the pipe.

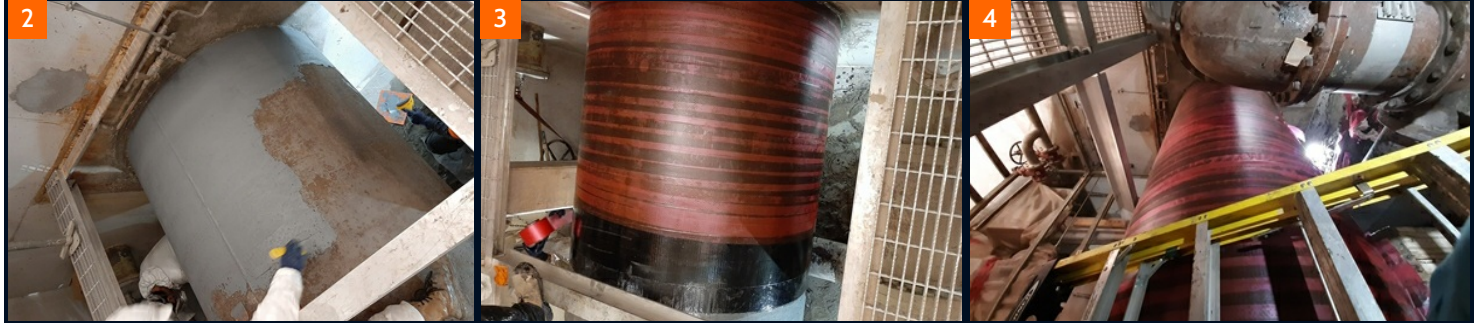
## PHOTOS

1. Corroded section of the pipe
2. Application of Belzona 1121
3. Wrapping in 4 feet sections
4. Wrap completed and consolidated with Belzona 9382

We used ASME PCC2 equations to estimate the number of wraps required to retrofit the pipe to design conditions. The defect was type A (thin wall), corrosion was external, and the pressure was relatively low (25 psi). 2 wraps of Belzona SWII were recommended to structurally reinforce the pipe and effectively stop corrosion on the pipe. This repair system can remain maintenance-free for up to 20 years.

First, the pipe was grit blasted and prepared according to SSPC SP10. All the pitting and resurfacing was then done with Belzona 1121(Super XL-Metal) because of its longer overcoating time. The next day, they started applying Belzona SWII. They applied the wrap in 4 feet sections at a time, so every 4 feet they would consolidate the repair with Belzona 9382 and continue with the next section. Though the application was during colder climate, Belzona 1982 was chosen to give more working life and allow the crew to complete the application properly.
