# BELZONA TRIALS NEW SF6 LEAK SOLUTION

ID: 9332

Electric Switch Gear flange within a Power Distribution Substation.

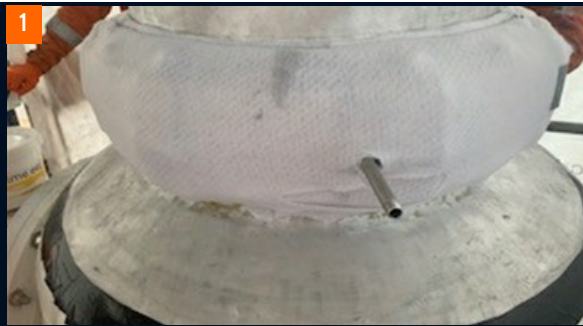
1. SF6 flange following surface preparation to SSPC-SP11, installation of the Backing Rod, tape, Redirection Nozzle & Breather Membrane.
2. Wetting out of the Breather Membrane and vertical application of Reinforcement Sheets (Belzona 9341) using Belzona 7311.
3. Post-application of 5x wraps of reinforcement sheet (Belzona 9371) and Belzona 1981 resin.
4. Final application after a further encapsulating layer of Belzona 7311.

The substrate (Aluminium) was first prepared in accordance with SSPC-SP11 Surface Preparation using an MBX (using a Stainless Steel wheel to prevent bi-metallic contamination). Once prepared, a backing-rod was applied behind the flange bolts and tape was applied over the bolts themselves (this prevents Belzona from adhering to them and allows a smoother surface transition). A Breather Membrane was applied around the circumference of the flange encapsulating it in its entirety, a Redirection Nozzle was also fitted to channel the leaking gas. Belzona 7311 was then applied to seal the membrane prior to the application of the impregnated Belzona 9341 (Reinforcement Sheet). The newly applied Belzona 7311 was then wetted out using Belzona 1981 (Winter Grade) SWII Resin prior to the application of 5 x wraps of Belzona 9371 (SWI Reinforcement Sheet) forming 10-layers (due to the 50% overlap). This was then left to polymerise (generating a slight self-curing exotherm) prior to a final encapsulating layer of Belzona 7311. The application required approximately 6L of Belzona 7311 & 5L of Belzona 1981. The application was carried out in accordance with a modified version of Belzona System Leaflet VPF-12.
