# BELZONA PROTECTS NEWBUILT LIFT STATION TANK IN A MARINE VESSEL.

ID: 9349

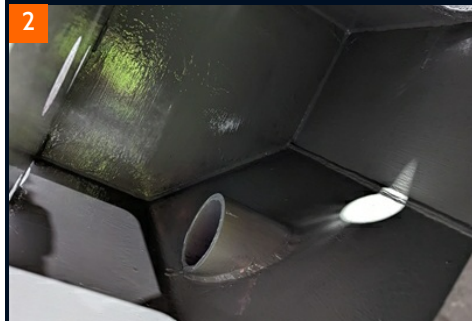
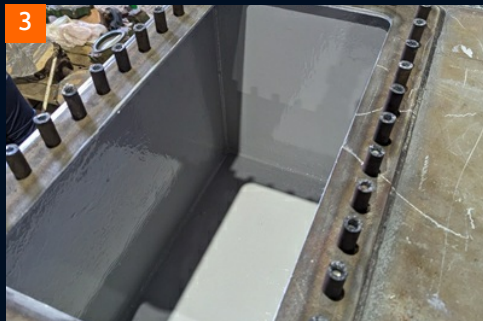
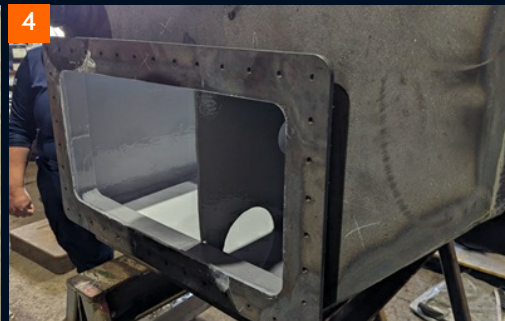
1. After application of Belzona 5892.
2. After application of Belzona 5892.
3. After application of Belzona 5892.
4. After application of Belzona 5892.

Power tool cleaning was done and two coats of Belzona 5892 was applied.
