# BELZONA ROOF REPAIR IN ORE MINE

ID: 9386

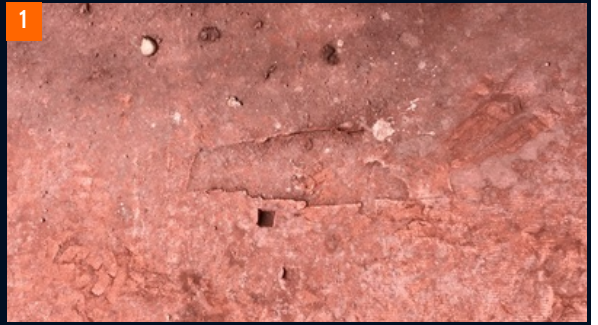
The old weather proofing systems had failed and there was water and dust entering these substation roof through the seams and joints.

1. Leaking roof area
2. Surface preparation
3. Application in progress
4. Another area being coated
