# BELZONA FORMS FLEXIBLE SEAL IN CHEMICAL LOADING AREA

ID: 94

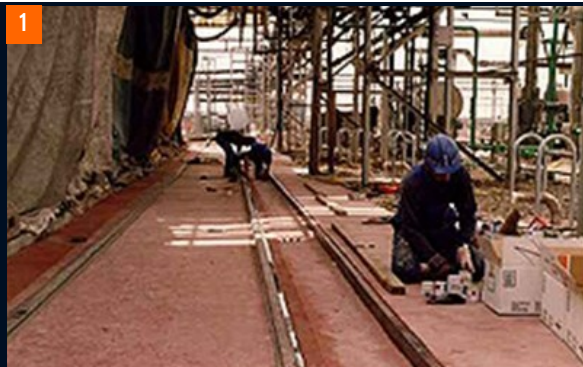
Rail tanker loading bay

1. General view of the loading area
2. Belzona 2221 being poured to seal between screed and rail
3. On site supervision provided by the Consultant to ensure specification was closely followed

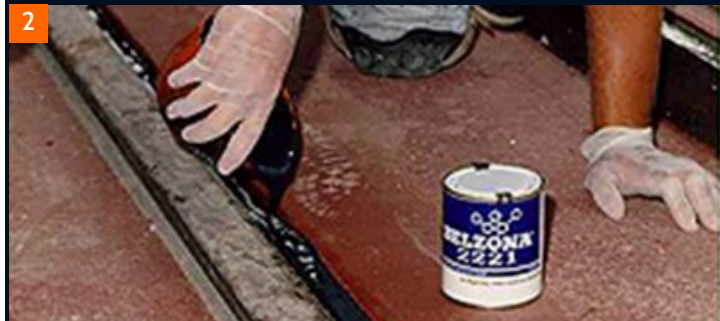
Seal required between concrete/epoxy screed and steel rails to prevent ingress of chemicals

Application was carried out in accordance with Belzona System Leaflet TCC-12
