# BELZONA SEAL-A-TANK TO THE RESCUE

ID: 9408

## PROBLEM

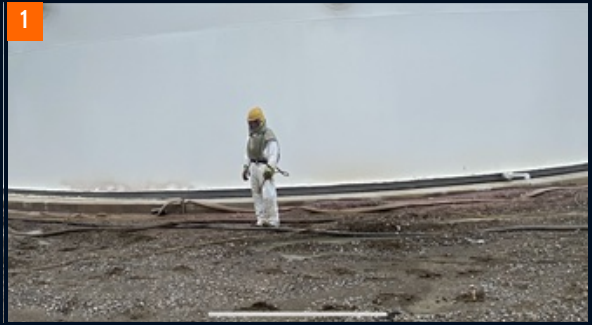
1. Blasting was being performed to prepare the carbon steel on the tank and the concrete for product application.
2. Blasting had been completed. Cleanup was done then conditioner applied to prepare for product application.
3. 3111 with 9311 reinforcement cloth being applied to the tank and concrete.
4. The project was completed in 3 days and the customer was very happy with the results.

The tank and concrete were blasted for preparation. Then the area was cleaned. After that 3921 conditioner was applied. After this 3111 in conjunction with 9311 was applied to complete the Seal-A-Tank application.
