# BELZONA FLORIDA REPAIRS STEEL MILL

ID: 9416

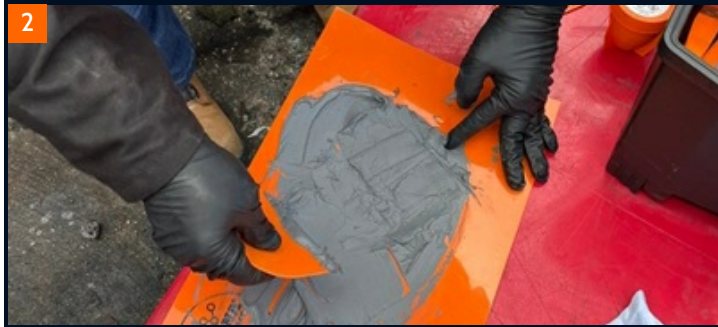
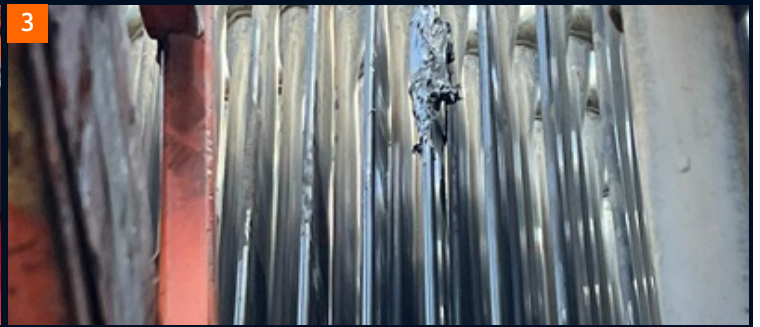
The transformer could not be shut down and the leak was live. It was constantly spitting a stream of cooling oil.

1. Leaking transformer
2. Mixing the product together
3. Area completely repaired using the product

While on site, we did not have Belzona 9611 available, so we prepared a batch of Belzona 1212. We allowed the mixture to reach the six-minute mark of its working life, during which it warmed up and began to cure. At this point, the Belzona 1212 material had hardened sufficiently to be used as a plug. Using a Belzona applicator, we pressed the Belzona 1212 into the live leak hole, effectively sealing it instantly. We also provided instructions to the onsite technicians on how to mix and apply the material. This repair was performed three years ago and remains effective to this day.
