# BELZONA SUPERWRAP APPLICATION ON AMMONIA PIPES

ID: 9441

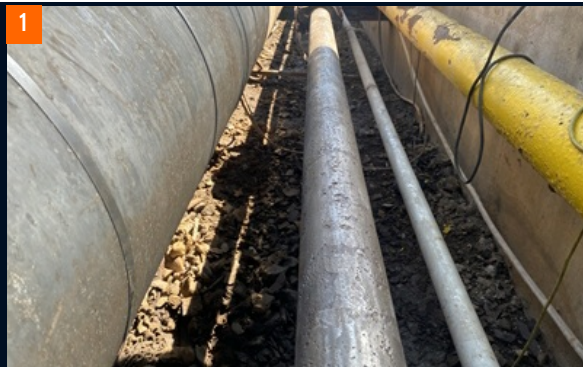
Belzona Superwrap II structural reinforcement system, under ASME PCC-2 standard, for 20 meters of buried pipe. This particular pipe was carrying ammonia. The pipe was experiencing pitting and wear and tear.

1. Corroded pipe used to carry ammonia.
2. Pipe during surface preparation.
3. The pipe is encapsulated with Belzona SuperWrap II.
4. The repaired pipe overcoated with Belzona 5811
