# BELZONA HELPS MAKE QUALITY CHIPS

ID: 9457

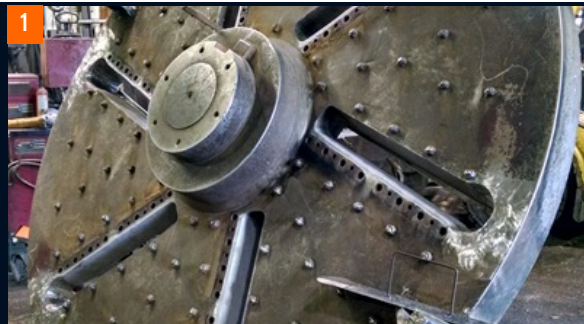
1. The chipper disk.
2. One of the pockets ready for application.
3. Starting the application.
4. Application completed.

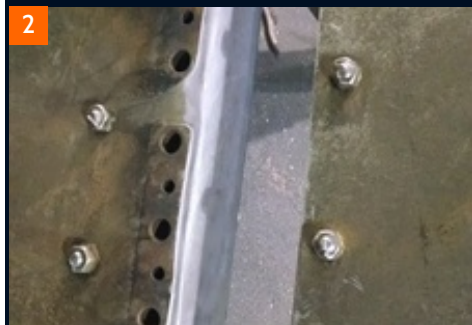
The pockets where the chipper knives are mounted were wearing out.

The application surface was prepped by grit blasting, solvent washed, and the Belzona 1811 was applied using the mixing knife, applicator, and by hand. Once the material was firm enough, the surface was smoothed down by hand using soapy water, creating a fine smooth finish.
