# BELZONA SEALS THE CHECK VALVES

ID: 9461

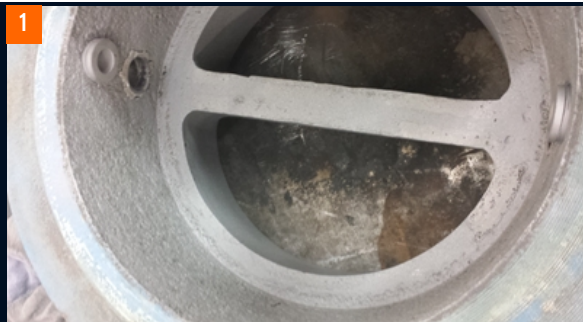
1. Check valve grit blasted and ready for application.
2. Belzona 9411 Release Agent being applied to the steel former.
3. Applying Belzona 2111 to the gasket surface.
4. Belzona 2111 applied, former in place to leave a smooth even surface.

The metal was prepped by grit blasting and then washed with solvent. Belzona 2911 Conditioner was applied and allowed to dry per the Instructions For Use. Belzona 9411 Release Agent was applied to the metal former and allowed to dry per the Instructions For Use. Once all of the parts were ready, Belzona 2111 was applied and the former carefully set into place and allowed to cure. Once the Belzona 2111 was cured, the excess material was trimmed out.
