# BELZONA 4311 PROTECTS CHEMICAL CONTAINMENTS

ID: 9467

## PROBLEM

Our client had three new containments that he was looking to coat and protect from chemical attack. The chemicals were ferric chloride, sulfuric acid, and caustic soda.

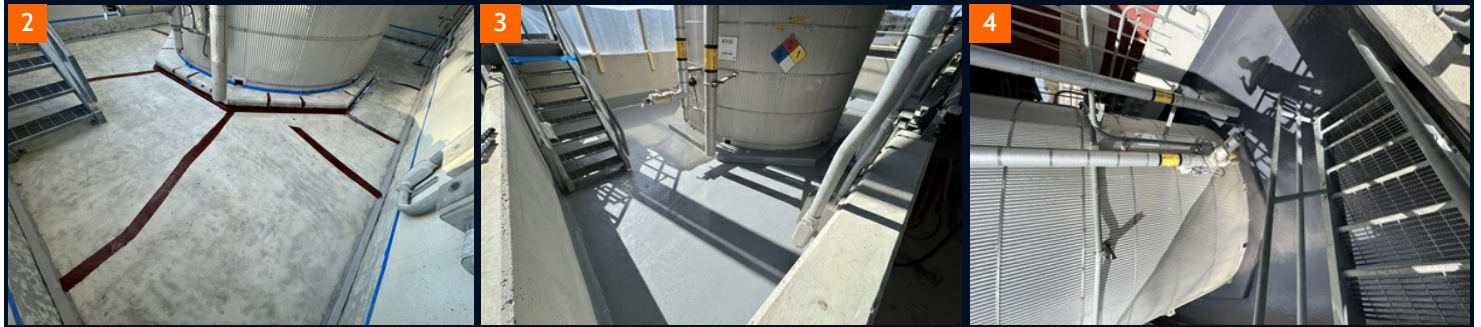
1. Sandblasted (3) containment areas
2. Addressed Cracks and Seams with Belzona 4361 and composite tape
3. Applied (1) coat of Belzona 5811
4. Applied 1 final Coat of Belzona 4311

We sandblasted the containments areas first. We then built coves out of Belzona 4111 to all wall/floor area. We then applied 1 coat of 5811 and 1 coat of 4311.
