# KINGSPAN JOINT SEALING

ID: 9476

## PROBLEM

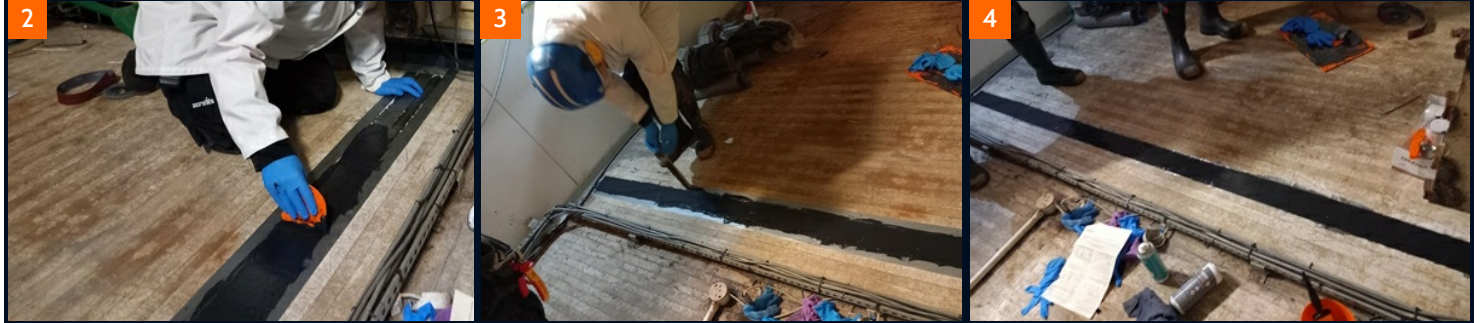
Condensation from local chillers were forming puddles and a build up of standing water over the Kingspan roof sheets of a large chiller room. The water would stand, then penetrate the joints, leaking into the chiller itself, where moving aerial conveyor hooks transported the food product below. The joints needed to be sealed so a trial was sought

1. Setting out the works
2. Finishing off the application
3. Removing masking
4. Masking removed showing the completed works

Access was gained to the roof space above the chiller  
The target area was prepared by grinding in a cross hatch pattern to gain best effort preparation to the steel kingspan sheets  
The area was degreased and cleaned using Belzona 9111  
Masking tape was used to gain clean lines on the finished application  
A thin coat of 2911 was applied and allowed to cure to touch dry.  
Belzona 2211 was mixed and the Kingspan joint was wetted out, as was the Belzona 9431 reinforcing sheet which was applied over the wetted out Kingspan  
Belzona 2211 was applied using a Belzona applicator to complete the works  
The masking was removed immediately
