# BELZONA GIVES THE ROLLER TRACTION

ID: 9492

## PROBLEM

This smooth steel roller was having problems moving the lumber efficiently.

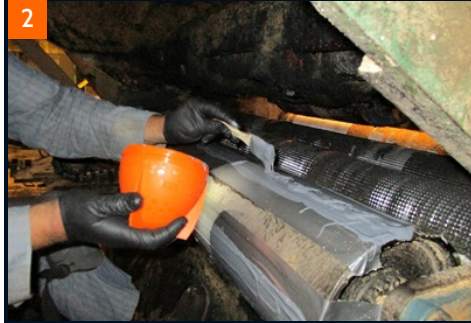
1. The roller with four sections taped off and hand ground, solvent washed and ready for application.
2. Applying a heavy layer of Belzona 1321 to the application zone before liberally sprinkling Belzona 9221 aggregate into it.
3. Belzona 9221 aggregate sprinkled into the Belzona 1321 to refusal and packed down.
4. Application complete.

A 4" hand grinder was used to heavily roughen the surface where the application was going to be. The area was thoroughly washed with solvent, and the Belzona 1321 was applied in one heavy coat about 15-20 mils thick before having the Belzona 9221 aggregate sprinkled into it and gently packed down with a small board.
