# BELZONA SUPERWRAP II APPLICATION ON 24 INCH ELBOWS

ID: 9501

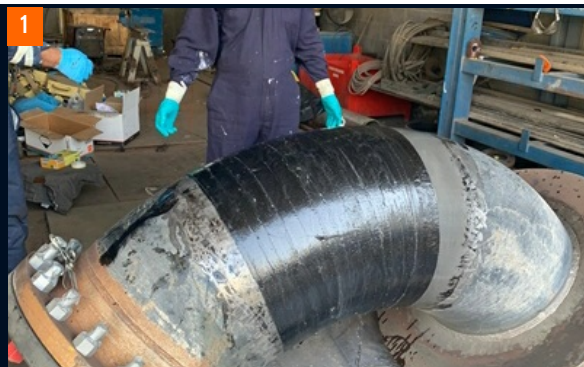
1. Trial/demo application of Belzona SuperWrap II as per the engineered design.
2. No trace of any leak or peel-off after the completed hydrotest.
3. SuperWrap II application for 24-inch elbow of 3.6 m length.
4. SuperWrap II application by distributor

The Belzona SW II application was carried out in accordance with the design method statement. The elbows were grit blasted to achieve a near white metal finish. The substrate was cleaned and degreased before the application. Belzona 1111 was used to resurface and smooth the weld seams. SW II Belzona 1982 resin and Belzona 9381 245mm width reinforcement tape were applied in accordance with the design specifications."
