# BELZONA BONDS BUSHES INTO TETHER BLOCK

ID: 951

Requirement to secure Bushes into the Tether Block for a 5 megawatts power generation buoy to be located in the North Sea

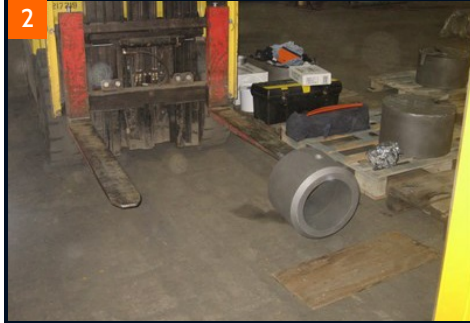
1. Tether Blocks
2. Bush
3. Dry fit of Bush
4. Completed job

Application was carried out in accordance with a modified Belzona Know-How System Leaflet MPT-8.
