# ENHANCING AMPHITHEATER SAFETY WITH BELZONA 4411

ID: 9510

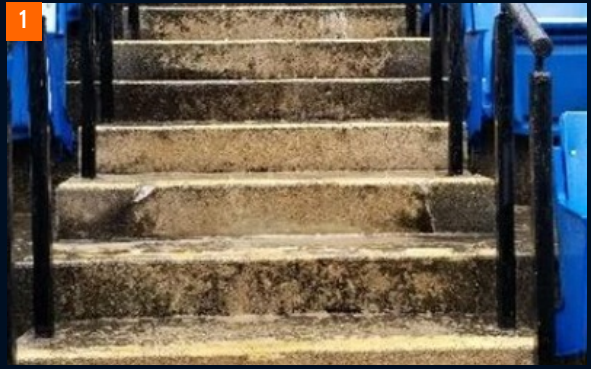
The amphitheater, once a popular venue, had become old and worn out. The steps and walkways were decaying and slippery, creating a safety risk for visitors. The city planned to renovate the entire structure, including these critical areas, to make it safe and functional again. The project involved updating several parts of the amphitheater to restore its safety and appearance.

1. State of the steps before renovation project
2. Surface prep and placing masking tape before application
3. Application of Belzona 4411 with 9211
4. Steps after 2 years in service
