# BELZONA MATERIALS REPAIR, PROTECT AND IMPROVE SEVERALLY DAMAGED DIFFUSER FOR PUMP STATION

ID: 9528

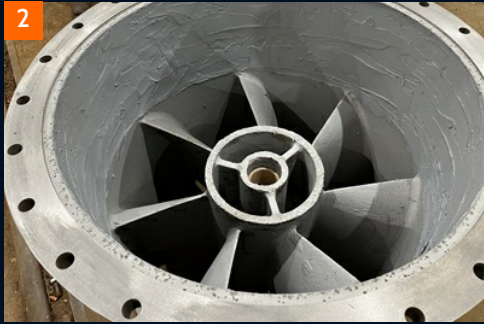
2

1. Initial Damage
2. Metal loss rebuilt with Belzona 1111 Super Metal
3. Exterior of diffuser reinforced with Belzona Superwrap II System
4. Interior of diffuser protected with two coats of Belzona 2141 ACR Elastomer (top coat of black shown)

A modified version of system leaflet CEP\_1 was used to rebuild the metal loss utilizing Belzona 1111 Super Metal. The exterior of the diffuser was reinforced using the Belzona Superwrap II carbon fiber wrap system. Finally two coats of Belzona 2141 ACR fluid were applied to the interior to protect against the devastating effects of cavitation.
