# BELZONA SLOWS DOWN MOLD AND MILDEW ISSUE FOR LOCAL COUNCIL

ID: 9530

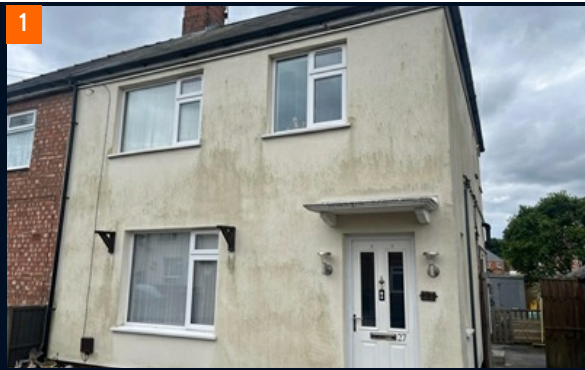
An issue was identified whereby the build up and growth of mold and mildew to shaded elevations needed to be stopped or slowed down. Belzona was approached to supply a solution to alleviate the build up of mold and mildew by effectively preventing the rendered environment from absorbing moisture

1. Rendered property suffering a build up of mold and mildew
2. Preparation: Washing down the rendered walls with HP water & fungicidal wash prior to fixing any cracks or damaged rendered surfaces
3. The property after the application of the Belzona 5122, appearing completely invisible
4. A full year on, Belzona has protected the render from moss, lichen, mildew and mold growth by restricting moisture absorption through every season.

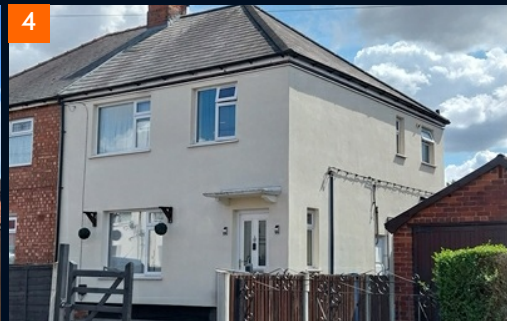
There has been no sign of the return of mold or mildew a year later, and since the trial went ahead, a further 13 properties have been listed for the same application, leading to 180 assets eventually being treated over the next 18 months. a year later, the 5122 has prevented all mold growth.
