# BELZONA PROTECTS ELBOW

ID: 9587

## PROBLEM

Abrasive material was wearing out elbows in an air handling system.

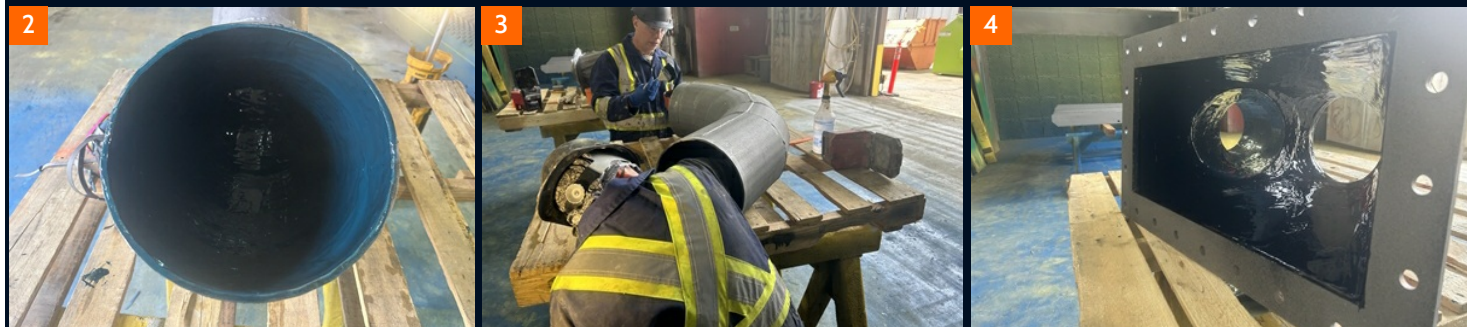
## PHOTOS

1. Area after initial preparation.
2. Base coat applied
3. Application in progress
4. Completed application

Highly abrasive resistant coating will protect this low angle abrasion pipe work for many years to come using easily applied Belzona's elastomers.

Grit blast completed, conditioner applied, elastomer base and top coats installed.
