# NEW DESALTERS LINING

ID: 9606

New carbon steel desalter vessels required corrosion protection.

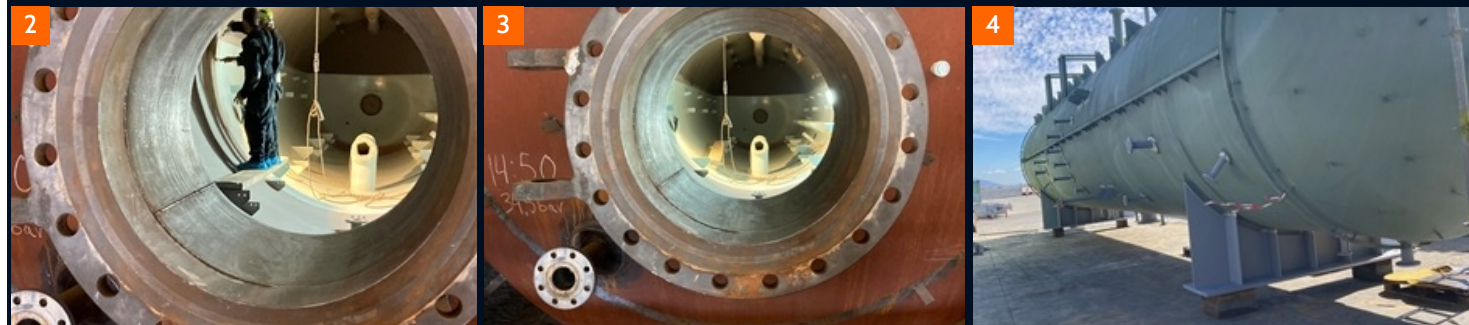
Operating conditions of the new Desalter Vessels will be immersion temperatures up to 160°C .

1. view of vessel
2. application in progress
3. application in progress
4. Vessel ready to delivered

The application was carried out in accordance with Belzona Know-How System Leaflet TCC-5. After grit blasting to SA 2.5 a two-coat system of Belzona 1593 was hand applied to the needed area
