# DRIVE ROLLER FOR A CONVEYOR BELT

ID: 9624

## PROBLEM

The customer wanted to refurbish their old drive motor conveyor pulley and have it resurfaced with Belzona

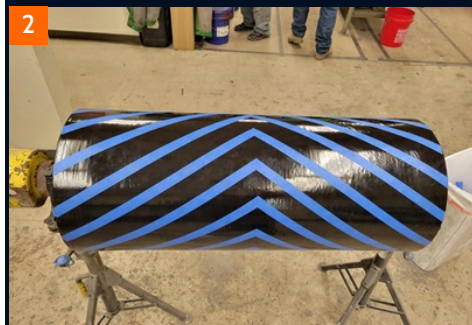
1. Belzona first coat on pulley
2. Demarcation on pulley for Belzona application
3. Belzona 2211 first coat
4. Belzona 2211 second coat
