# FEED ROTOR FOR CHP PLANT PROTECTED

ID: 9633

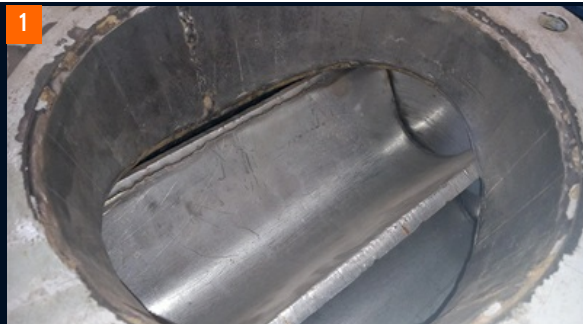
A stainless Fuel feeding rotor had suffered wear and damage, creating issues with leaks, back pressure and unwanted vacuums in the feeder process to the boiler in an industrial CHP (Combined Heat and Power plant)

1. The rotor whilst still in its original housing
2. Blasted with aluminium oxide to achieve SA2.5 and min 75 micron profile
3. Both coats of Belzona 1341 applied, ready to ship back to the customer
4. 1 year on and the coating is still perfect, doing exactly as intended by avoiding build up of material and allowing the rotor to perform at full efficiency, whilst protecting against erosion

The client required the dimensions of the stainless rotor to be brought back to the originals, then coated to help prevent and slow down future wear

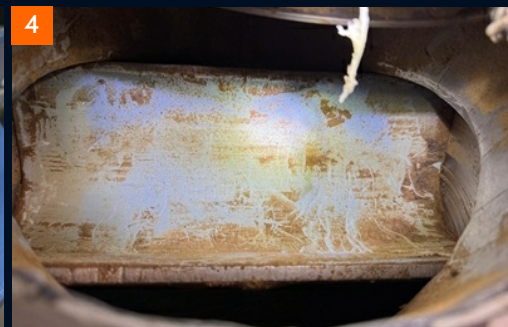
12 months on and the coating to the rotor is still in perfect condition, allowing for performance from the rotor with NO unexpected downtime or Reactive maintenance required.
