# BELZONA IMPROVES EFFICIENCY OF COOLING WATER CIRCULATION SYSTEM CENTRIFUGAL PUMP

ID: 9646

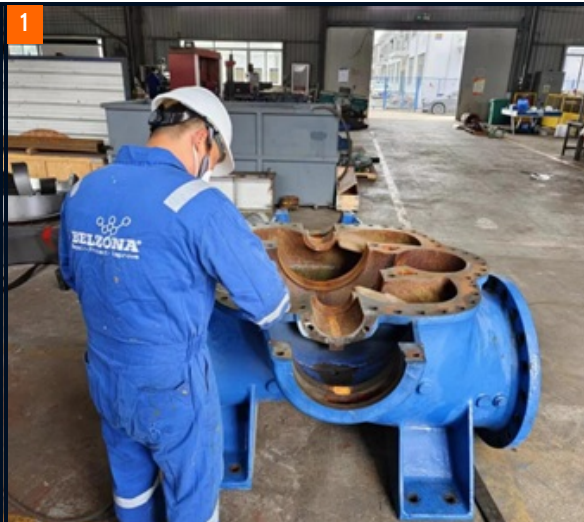
1. Degreasing and chamfering pump casing surface
2. Protection of matching surface before surface preparation
3. 2 coatings of Belzona 1341 completed
4. Dynamic balancing test after the impeller is coated with Belzona 1341

The application was carried out in accordance with Belzona System Leaflet CEP-10. First, all sharp edges were grounded to give a radius of not less than 3 mm and the matching surfaces were protected. Then, grit blasting was performed. After cleaning, Belzona 1111 was used to repair and fill pits. Belzona 1341 coating was used for protection and efficiency improvement. After completion, the impeller was dynamically balanced.
