# BELZONA PROTECTS STORAGE VESSEL FROM CHEMICAL ATTACK.

ID: 9705

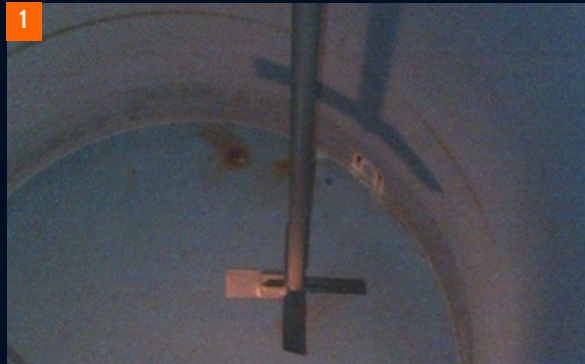
1. Tank before abrasive blasting.
2. After abrasive blasting surface preparation
3. During stripe coating of Belzona 4311
4. Lining application completed with Belzona 4311.

The tank and drain areas were blasted to achieve a near white metal finish with a good profile. After the required QA/QC checks, Belzona 4311 was applied to protect the tank and other components from corrosion and offer concentrated chemical resistance.
