# BELZONA 1341 USED TO COAT FLOOD CONTROL PUMPS

ID: 9725

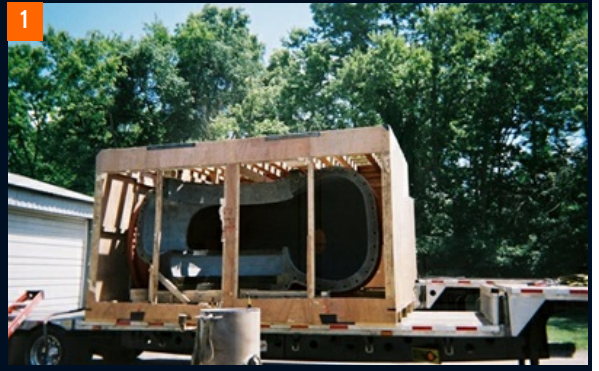
1. These pumps were delivered on flatbed trucks from California after being shipped over from Japan.
2. Applicator checking millage of the Belzona 1341 (Supermetalgilde).
3. Finished application, ready to close up the shipping crate and ship on to the customer.

Grit blasted to a 3-mil profile and spray applied Belzona 1341 (Supermetalgilde) with two 10-mil coats.
