# BONDING OF 325MM STEEL PIPE INTO 500MM THICK CONCRETE WALL WITH BELZONA 1212

ID: 9728

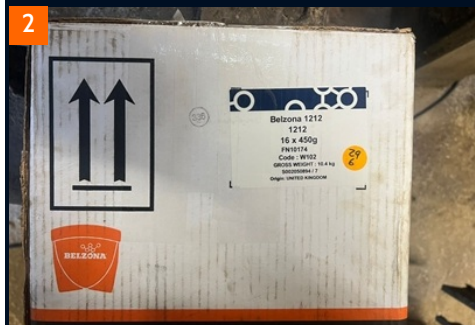
1. 350mm Diamond Tip Core Drilling 500mm thick through the Pulp chest Wall - 50mm Re Bar inside . The core drilling took 8 hours alone.
2. Belzona 1212 was selected to seal and bond the 325mm OD steel pipe into the chest wall as we only had 12 hours on the shut.
3. 325mm Inside Return line located inside the Pulp chest
4. 325mm Outside Return line located outside the Pulp chest. From here an expansion joint was installed and the pipe was coupled into the common pump pipeline.
