# FLEET FACILITY FLOORS ARE CLEANER AND SAFER THANKS TO BELZONA 5231

ID: 9730

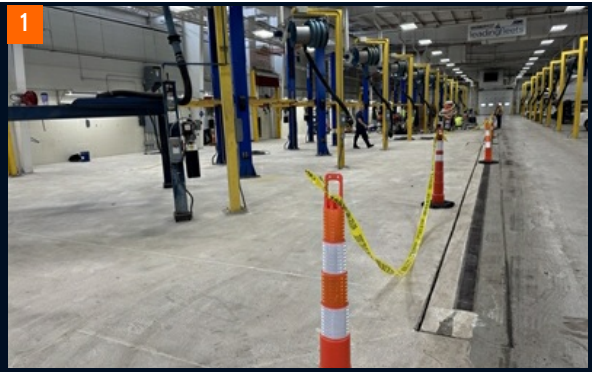
This municipality coated their fleet facility floor when it was built 8 years ago. The coating started failing in two years so then they decided to just apply another coating on top of the failing one. That got them to 2023 when they started looking for a real solution.

1. This building is being done in 4 sections. This area has been blast cleaned and is ready for Belzona 5231.
2. Expansion joints are being rebuilt with foam backer rod, Belzona 4911 and Belzona 4521.
3. Finished section.
4. Finished section.

The contractor had to remove 2 layers of old floor coating by grit blasting and scraping. Belzona 4911 (TX-Conditioner) was "stippled" into the substrate. Then foam backer rod was inserted to the correct depth. Belzona 4521 was then applied per the IFU. Lastly, two 6-mil coats of Belzona 5231 (SG Laminate) with aggregate were applied by squeegee and roller over the entire section.
