# ENERGY EFFICIENCY AND CORROSION RESISTANCE BOOSTED IN NEW PUMP WITH BELZONA 1341

ID: 9741

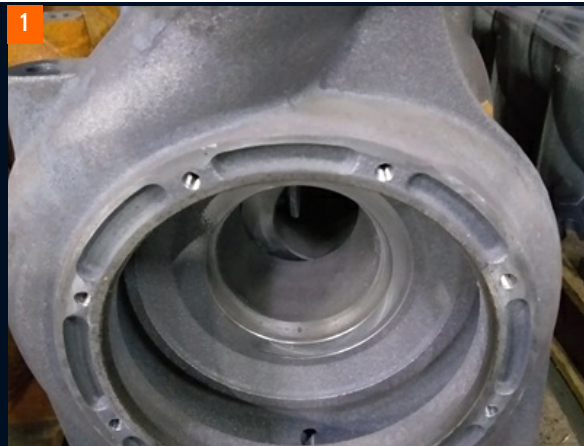
1. After grit blasting
2. The pump after application
3. The pump after application

Application was carried out in accordance to the Belzona Know-How System Leaflet CEP-10 . The surface of the new pump was prepared to SA 2 ½ with a minimal profile of 75 microns, and then coated with Belzona 1341 using a roller and brush.
