# DRINKING WATER SPLIT CASING PUMP COATING

ID: 9749

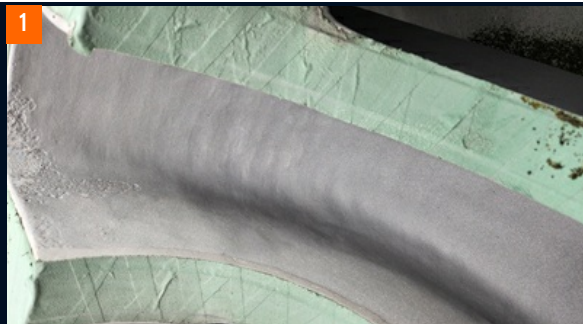
Pumps work 24/7 to provide drinking water for residents; the 5 years of operations cause the pump to deteriorate, creating surface pitting and corrosion, so we recommended Belzona 1341 NSF grade to provide the necessary protection for the pump against the corrosion/erosion effects and at the same time drinking water grade approved. Customer is happy with the performance, as previous pumps stayed for 5 years.

1. Pump after blasting, surface pitting is visible
2. Pump coating with Belzona 1341
3. Final condition after inspection of the pump with Belzona 1111 and 2 coat system of Belzona 1341

We Grit blasted the surface to reach near white metal and 75 um microns as recommended by Belzona IFU. We made sure the salt level over the surface was very minimal, and we rebuilt the pitting with Belzona 1111, sweep blast, then 2 coat systems of 1341 at 250 um each to reach a total of 500 um average.
