# COATING OF TWO FABRICATED BUNDS FOR SULPHURIC ACID

ID: 9757

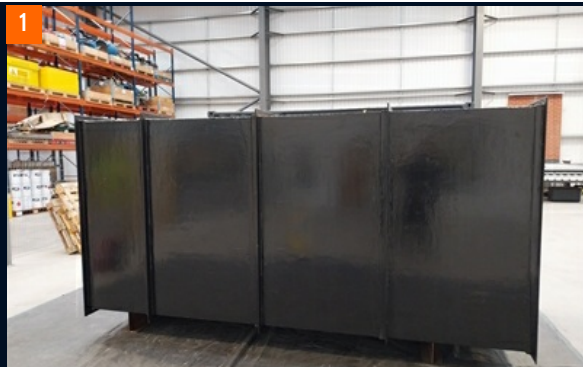
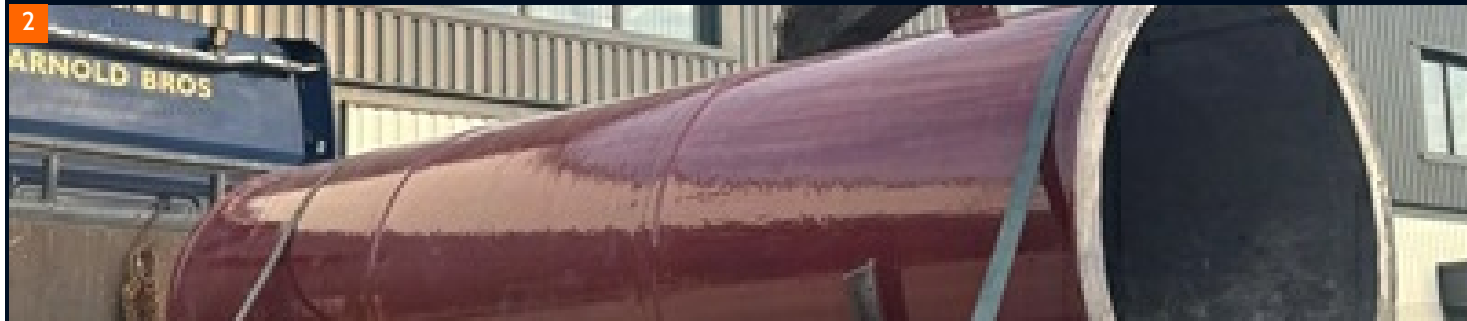
1. External Bund
2. Internal lead lined bund

Identify area for coating and clarify areas not for coating (sealing faces, internal of tank etc). Protect areas not for blasting using blast tape. Surface preparation will be carried out by grit blasting, within our state of the art blasting booth. Once the steel substrate has been prepared to a standard of minimum surface profile of 75µm and a surface cleanliness of SA 2½, our technicians will then brush apply a 2 coats system of Belzona® 4341 at a target thickness of 400µm per coat. When complete a full inspection will be carried out.
